RESEARCH PAPER

**Preservation and Regeneration of the Tomb of Abdul Nabi Khan (Kotli Maqbara) in District Gujranwala, Pakistan**

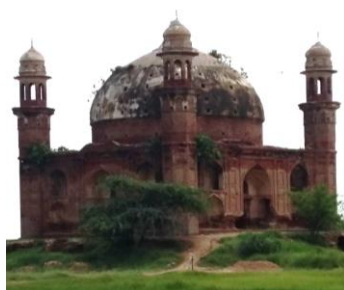
Figure 1: Northern View Perspective Figure 2 : View of Dome and Minaret Figure 3: View of Lower ground Entrance

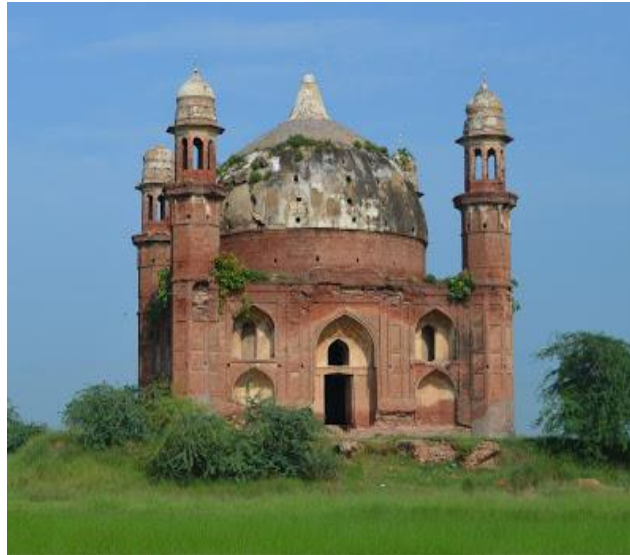
The tomb, initially built with red sandstone and an onion-shaped dome, was designed using a series of grids. The prime design feature is a pointed arch with a bordered triangle, applied on all scales at the unit complex for symmetry and architectural unity. This motif is evident in the pointed arches bordered by a rectangular frame, the large recessed portals dominating the exterior facades, and the small arches of the facade imitating this design.

Figure 13: Image of Tomb Abdul Nabi showing architectural details

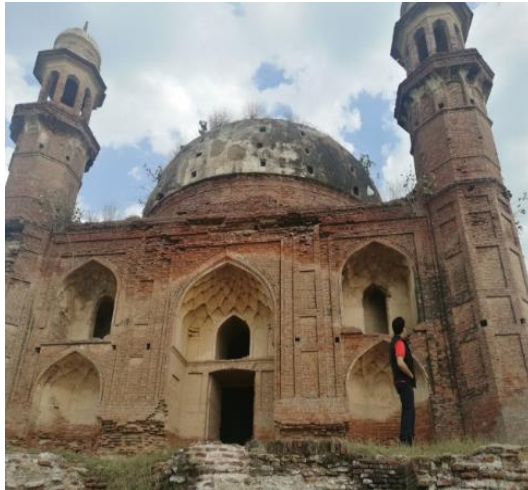
The tomb's exposure to various climatic conditions, including solar radiation, temperature, humidity, rain, wind speed, floods, and earthquakes, is primarily responsible for its unique challenges.

Figure 14: Façade of the tomb showing Climatic effects

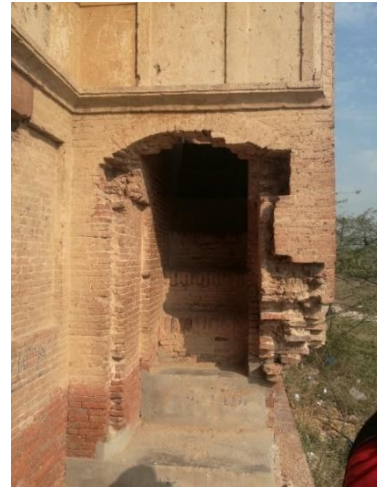
Figure 15: Structural damages due lack of maintenance

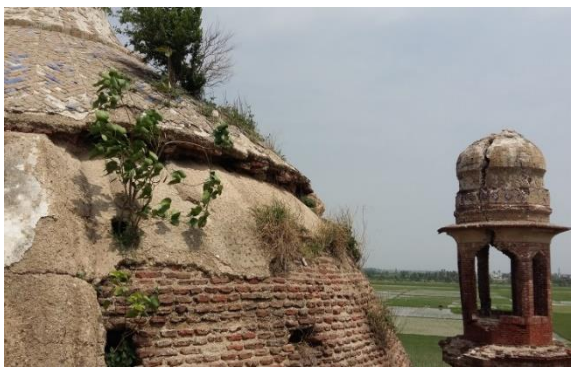
Gujranwala’s climate is varied, with temperatures ranging from 48°C to 0°C. Buildings exposed to solar radiation expand more, while internal and shaded parts remain cool. Thermal movements cause strain on materials, resulting in fissures and cracks between masonry joints. The Abdul Nabi exhibits these fissures and cracks, with vertical cracks on the upper portion and roof joints. Rainwater seeps through these cracks, damaging the interior. (Conant, 1954).

Figure 16: Structural Cracks in Copula of Minaret

The Minarets in the Tomb were in a fragile state, with the top and copula potentially falling down. To strengthen the base of the Copula, bricks of the same size as the overall construction is being used in the places where they have been removed or fallen down using limestone mortar. All bases of the minarets needs to be plastered with cement sand mortar, and local intervention have to be removed. Limestone which was the principle binding material of Mughal period is being used for conservation as shown in above figure. The Copula itself will require "Jacketing" to deal with the cracks.

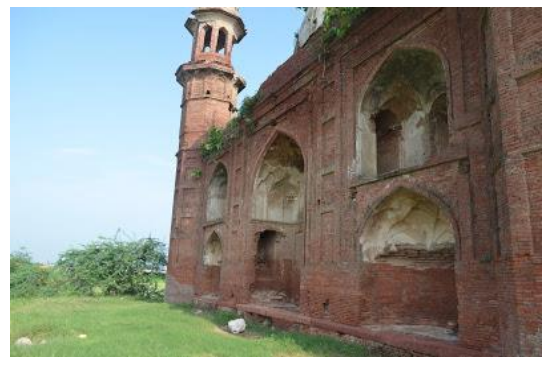
Figure 17: seepage of rain water

Once the plants are removed and holes are treated well with bricks and lime mortar, the seepage problem of the dome will automatically be removed and the life of the structure will be reinforced. The rest of the roof is also in a bad state, with gaps between brick masonry and holes that act as a water collector during rain, resulting in seepage and further

destruction of the ceiling. All holes should be filled back with bricks and proper filling of joints should be carried out after cleaning them thoroughly with a steel brush.

A completely new layer of bricks should be applied over the roof while maintaining good slope to remove any doubt of water seepage, increasing the age and durability of the monument. A 200-foot area around the tomb should be acquired and raised about 2 feet, creating a buffer zone between the tomb and the rice fields. French Trench will be constructed around the until the depth of the lower ground with 100 feet deep bores at the corners to drain water down to the ground. This will act as a plinth protection for the structure and prevent future water attacks.

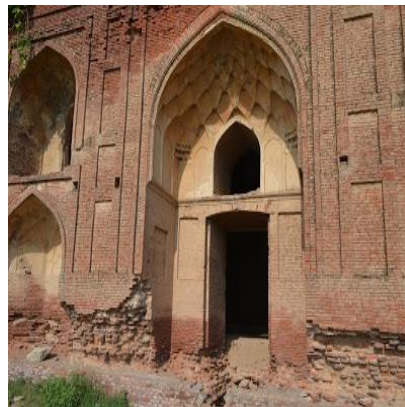
Bio-deterioration refers to negative changes in material properties caused by the growth of biological and micro-biological organisms. The Abdul Nabi is prone to bio-deterioration due to extensive dampness, with lichens and fungi blackening masonry, loosening, discoloration, cracking, and deteriorating brick masonry. Overgrowths of plants weaken the structure, and improper removal can further damage the monument.

The Abdul Nabi in Lahore, built of brick and red sandstone, is deteriorating due to 20 inches of annual rainfall. Rainwater penetrates the masonry, causing internal decay and destructive crystallization. Repeated dampening and drying cycles have caused contour scaling and cavity decay. Salt crystallization has also caused surface powdering. The lower ground, where the tomb's three graves are held, is at risk of rainwater damage.

Figure 18: Deterioration Figure 19: Damages due to rain water Figure 20: Biodegradation

The removal of Red stone from the floor of the tomb has ruined it considerably, but can be easily replaced. The Dome of the tomb is in the worst condition, with holes around it with plants growing out of each one. These holes need to be closed using bricks and lime mortar after removing the plants. Chemicals like Glyphosate and arsenate water can be used to block the photosynthetic process of the plants, killing them in a couple of weeks. The recommended method is to use chemicals as they are more effective and leave a rare chance of re-growth.

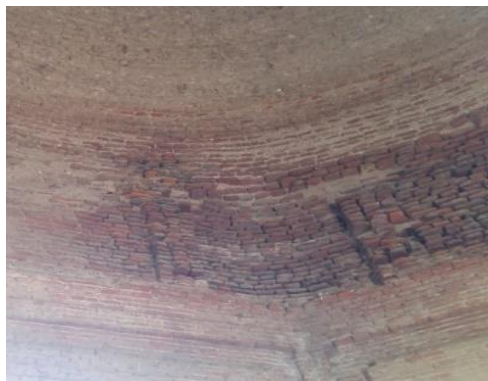
Figure 21 Damages in Internal side of Dome

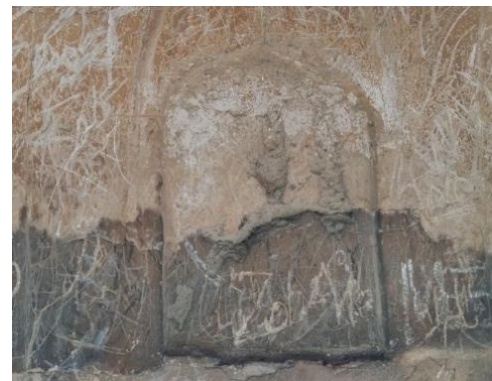
Figure 22: Human Vandalism

The monument in the wilderness has been severely damaged by vandalism, with many names carved into the masonry due to lack of regulatory authority. The lack of boundary walls and uncontrolled visitor inflows has led to damage, such as carving names or stealing the dome. The floor has also been sagging, with evidence of a previously existing red sandstone slab. The empty building attracts vandals of all types, including bored teenagers and professional thieves. The visitors damage the monuments by writing and making marks on the walls and roof they also climb with different elements of building.

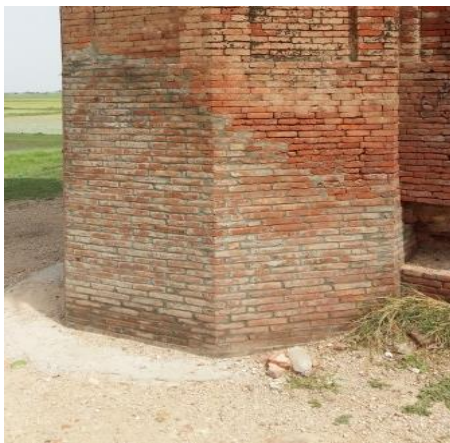
Poor conservation often results from a lack of technical understanding in restoration work, leading to inexpert or inappropriate materials that negatively react with the original material, causing further damage. For instance, cement, which is too sturdy in compression, bond, and strain, lacks elasticity and plasticity compared to lime mortar used in historic buildings. This imbalance can lead to additional fissures in adjacent areas, as seen in the use of cement in masonry repairs. Bernard M. Feilden, “cement is number one enemy of historic buildings”.

Figure 23 : Repair with cement

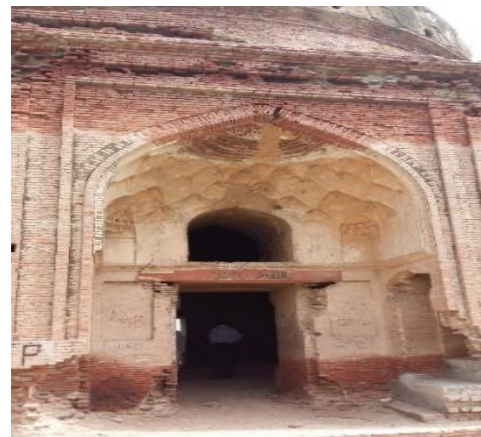
Figure 24: Poor Conservation Technique

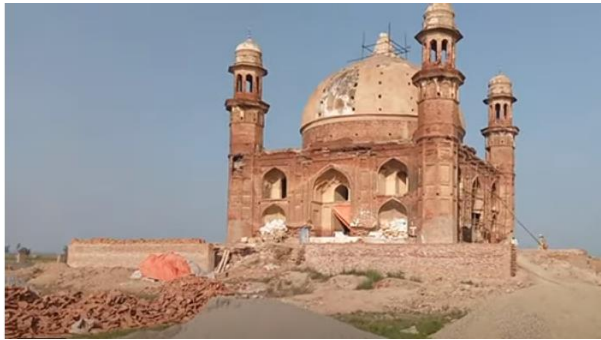
Figure 25 : Work in progress at Dome

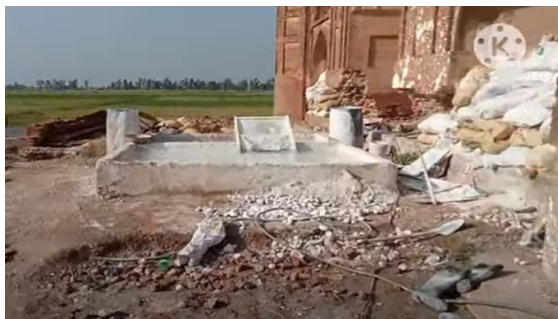
Figure 27: Lime mortar preparation at site

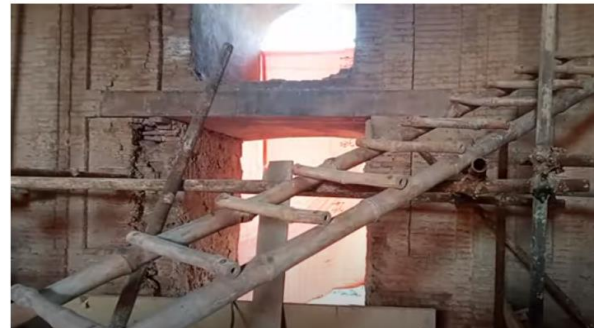
Figure 28: Formwork at Internal side
